SUBJECT: John Burch Park Project Change Order #2

CHANGE ORDER

CHANGE ORDER NO.: 2 PROJECT NO.: 9897.00
PROJECT NAME: John Burch Park Improvements
LOCATION: Cannon Falls, MN
CONTRACTOR: Blakeborough Hardscapes
ADDRESS: 24375 Edenvale Trail, Elko New Market, MN 55020

FIELD OBSERVATION REPORT

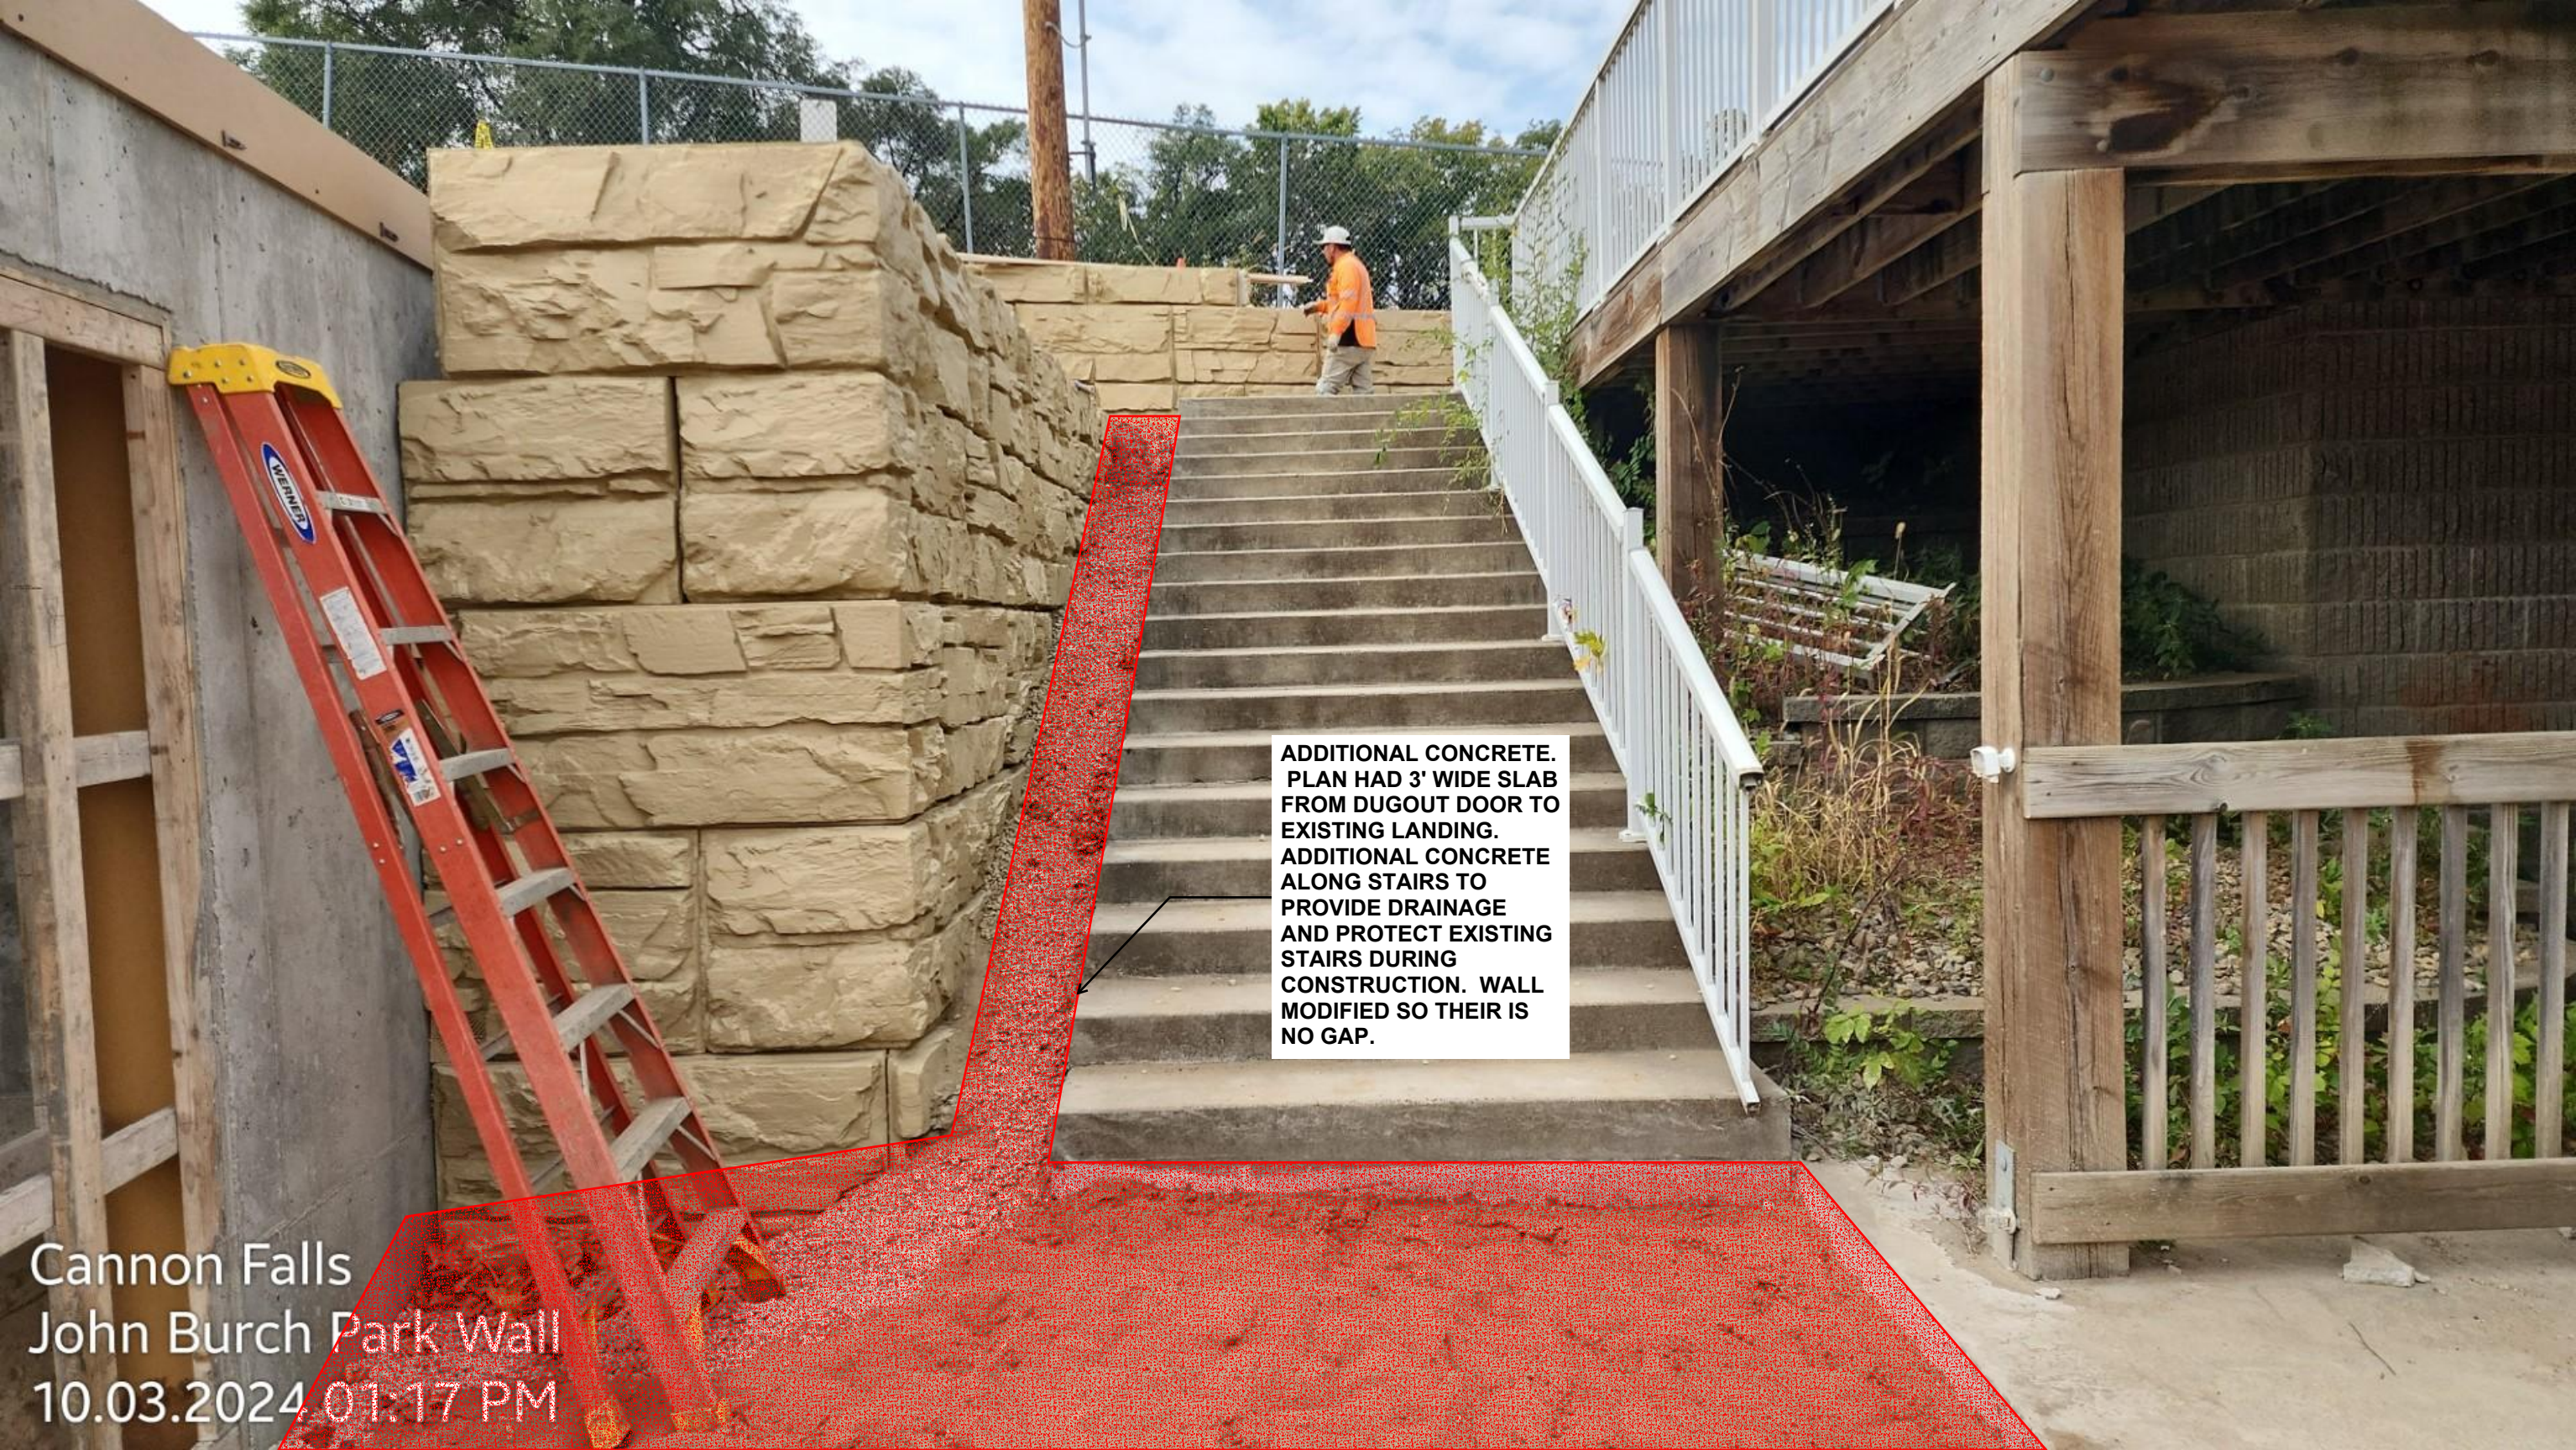
Cannon Falls
John Burch Park Wall
10.03.2024 01:17 PM

ADDITIONAL CONCRETE.
PLAN HAD 3' WIDE SLAB
FROM DUGOUT DOOR TO
EXISTING LANDING.
ADDITIONAL CONCRETE
ALONG STAIRS TO
PROVIDE DRAINAGE
AND PROTECT EXISTING
STAIRS DURING
CONSTRUCTION. WALL
MODIFIED SO THEIR IS
NO GAP.
