## **MEMORANDUM**

RE: First English Church - bank erosion

SEH No. CANNO 123363 14.00

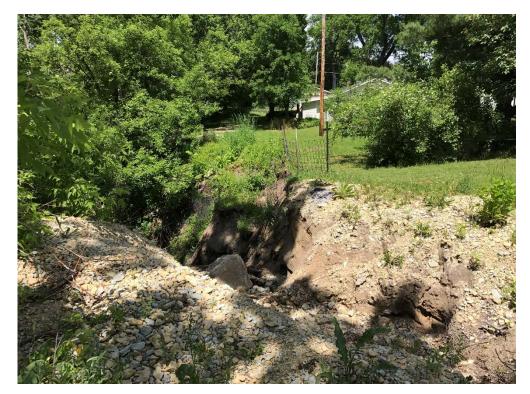
Photo 1 Facing north in 3rd Street SW ROW

The drainage off of the parking lot at First English Church flow west towards its outlet to the Little Cannon River across the 3<sup>rd</sup> Street SW right-of-way. The swale that carries this drainage down the slope towards the river was damaged during the September 22-24, 2016 storm event that caused other damage in the City that qualified for FEMA funds to repair. This bank has continued to erode due to it being the outlet for most of the church parking lot. The erosion has reached a point that is now threatening the existing sanitary sewer line in the 3<sup>rd</sup> Street SW right-of-way (see photos). Chief McCormick has worked with FEMA to secure funding to repair the eroded bank. Our original estimated project cost was approximately \$42,000. The City has typically received 100% funding of the project costs from FEMA on past projects. We are anticipating the same with this project.

We have prepared plans for a storm sewer line that would capture the runoff from the parking lot and pipe it down the slope to an outlet structure. After the pipe installation, the eroded bank would be filled and riprap would be placed to stabilize the bank. The construction plan is attached.

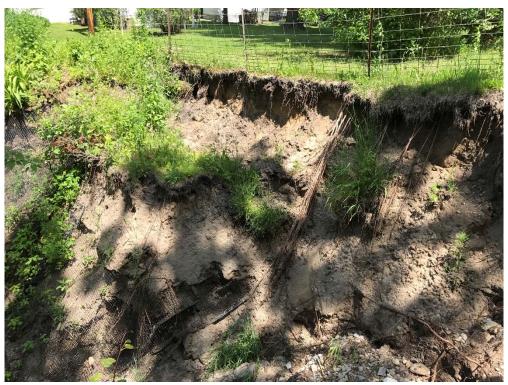
Photo 4 Eroded bank
